NASA-CR-159486
PWA-5615-3

STRAIN GAGE SYSTEM EVALUATION PROGRAM
FINAL REPORT

UNITED TECHNOLOGIES CORPORATION
PRATT & WHITNEY AIRCRAFT GROUP
COMMERCIAL PRODUCTS DIVISION

March 1979

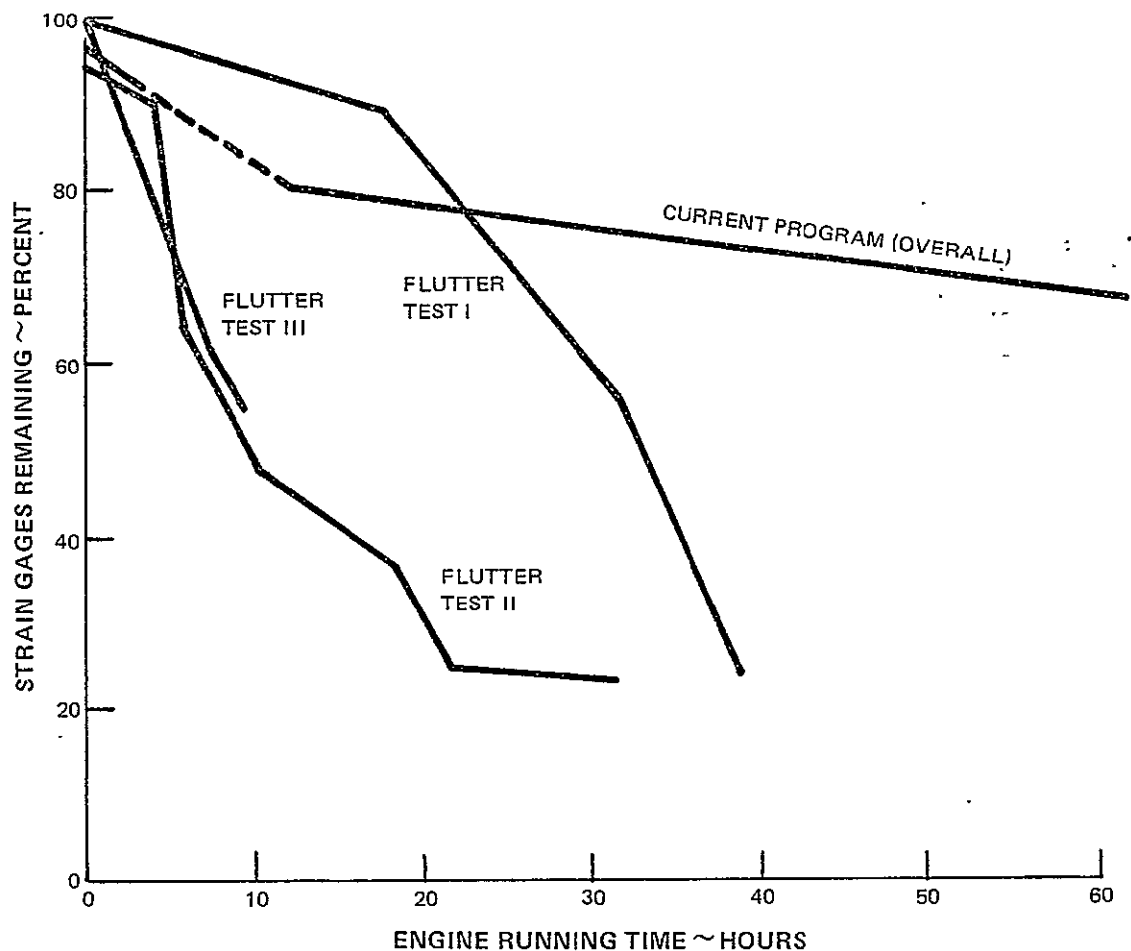
Figure 12 shows the strain gage system failure rate during engine testing together with the strain gage failure rate results for previous testing of this same engine type at NASA in flutter programs. As shown, a number of failures occurred during the first ten hours of testing, after which the failure rate was substantially slower. The initial higher failure rate is believed to be the result of poor jump formation. Unfortunately, most of these failures occurred during the time that the gages were not being monitored;

Figure 12 Strain Gage System Failure Rates for the Current Program and Previous Tests of the Same Engine Type

therefore, it is not known if the failures resulted from a single event or if they were spread throughout the first ten hours of engine running. However, no event is evident from the engine running logs that might be suspected of causing multiple gage system failures.

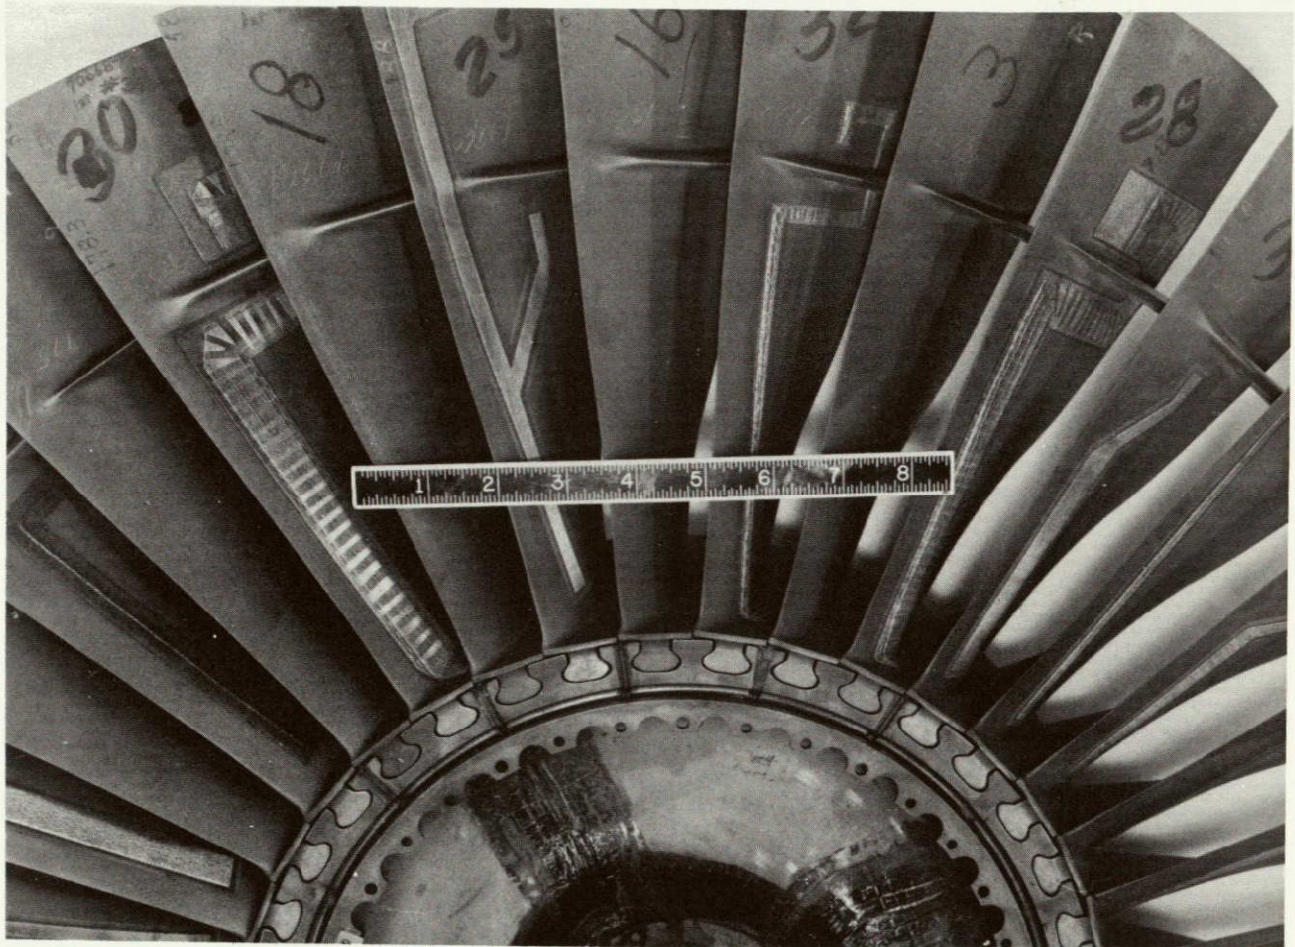
Figure A-2 Section of First Stage Instrumented Blade Assembly After
Testing - Convex Side

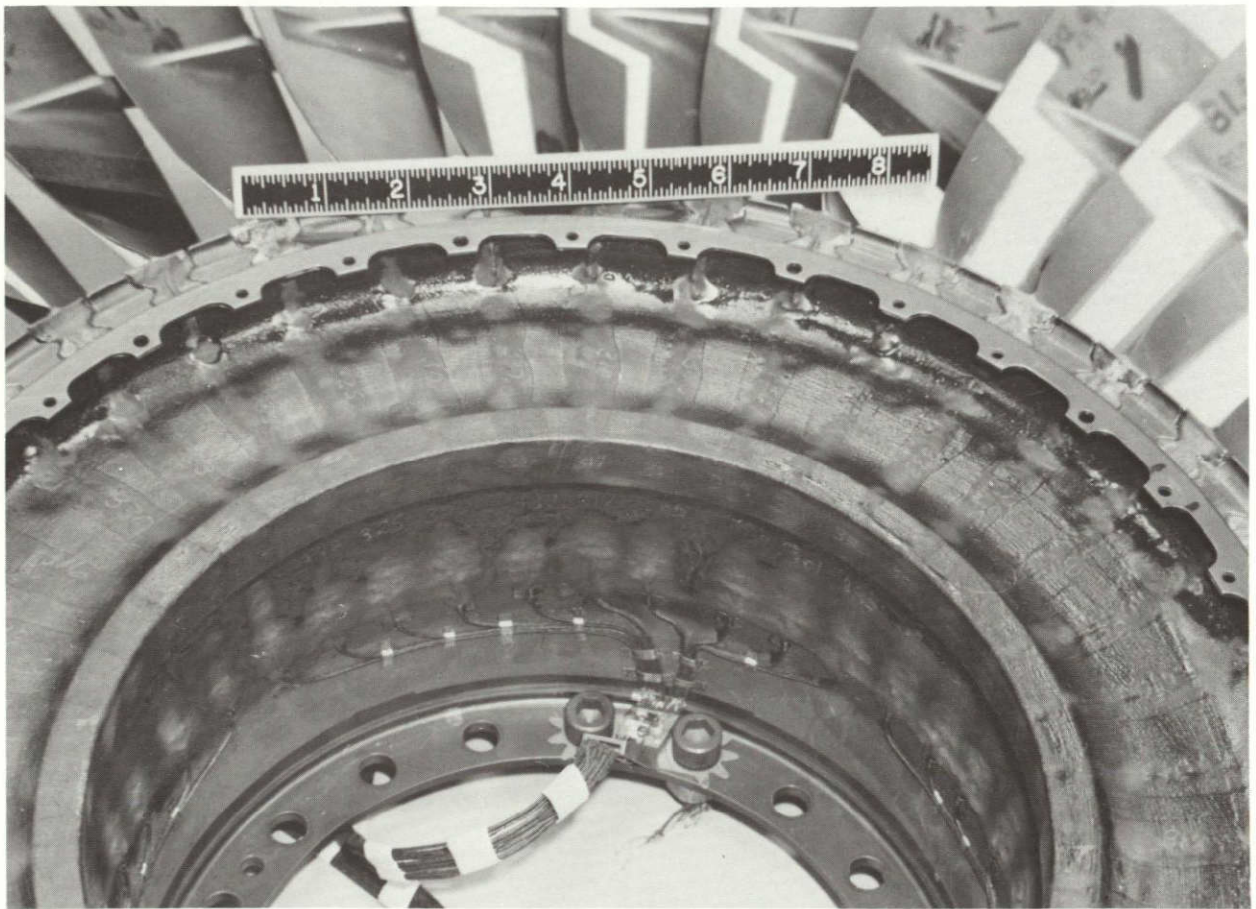
Figure A-5 Section of Third Stage Instrumented Blade Assembly After
Testing - Concave Side

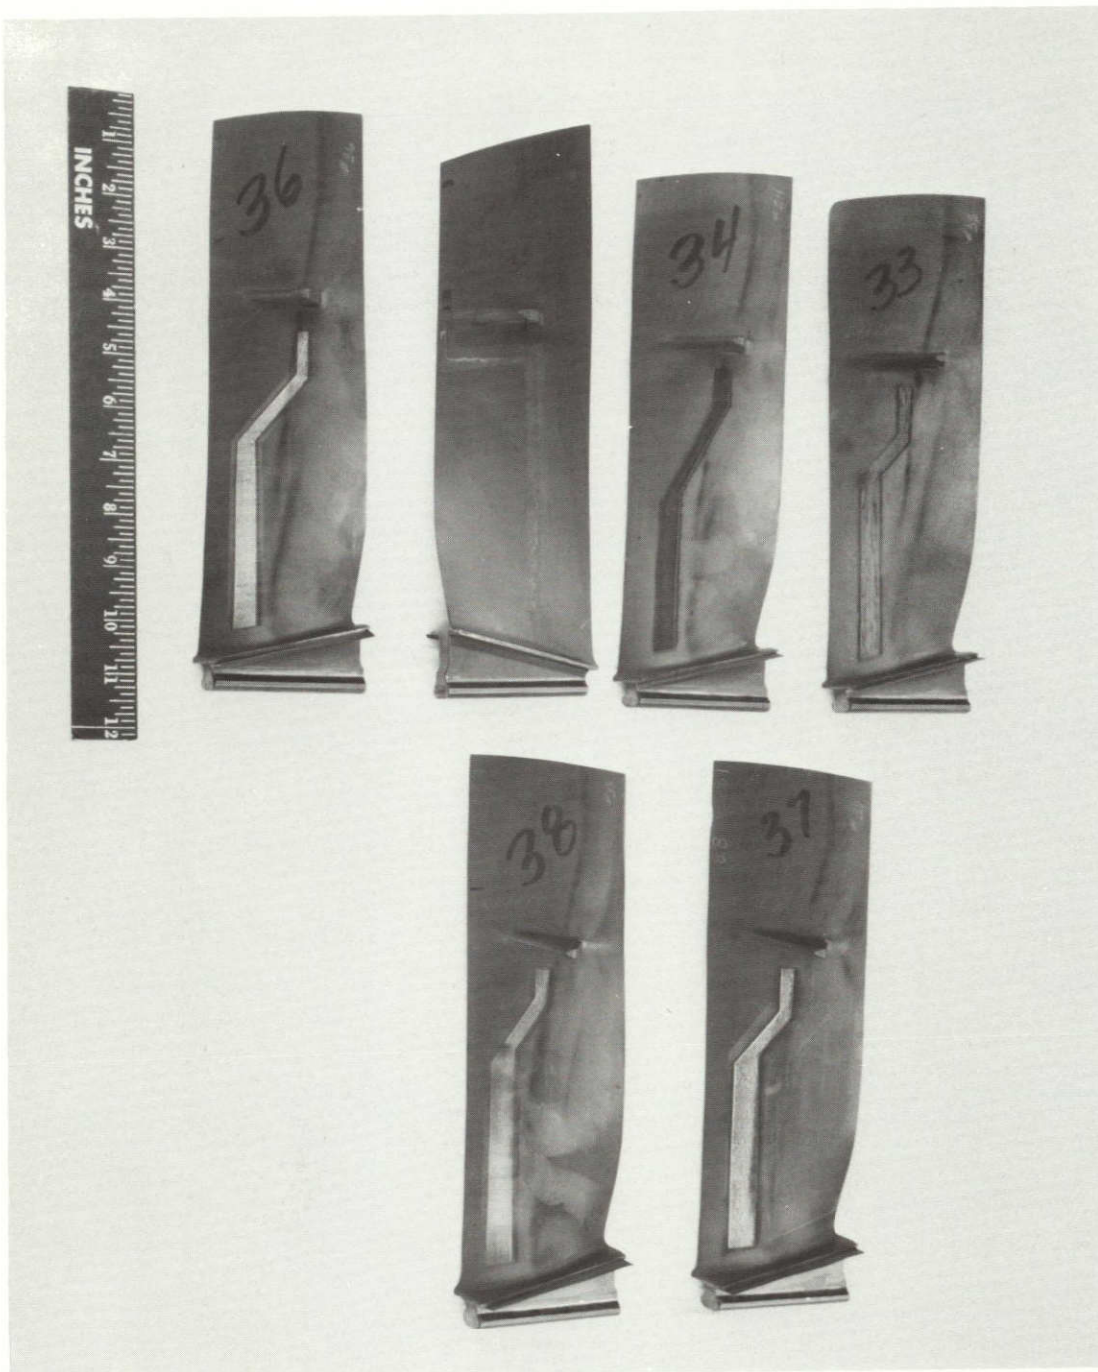
Erosion was severe on the concave surface of the first stage blades, but no gage failures were attributed to erosion damage. Results indicated that Rokide rod, used as a precoat and overcoat, was the best material used in gage installations with respect to erosion resistance. Gages and leadwires should be located away from high erosion areas, if possible.

Figure A-15 Erosion Patch First Stage Blades S/N 33 Through 38 After Testing (78-444-4233-E)

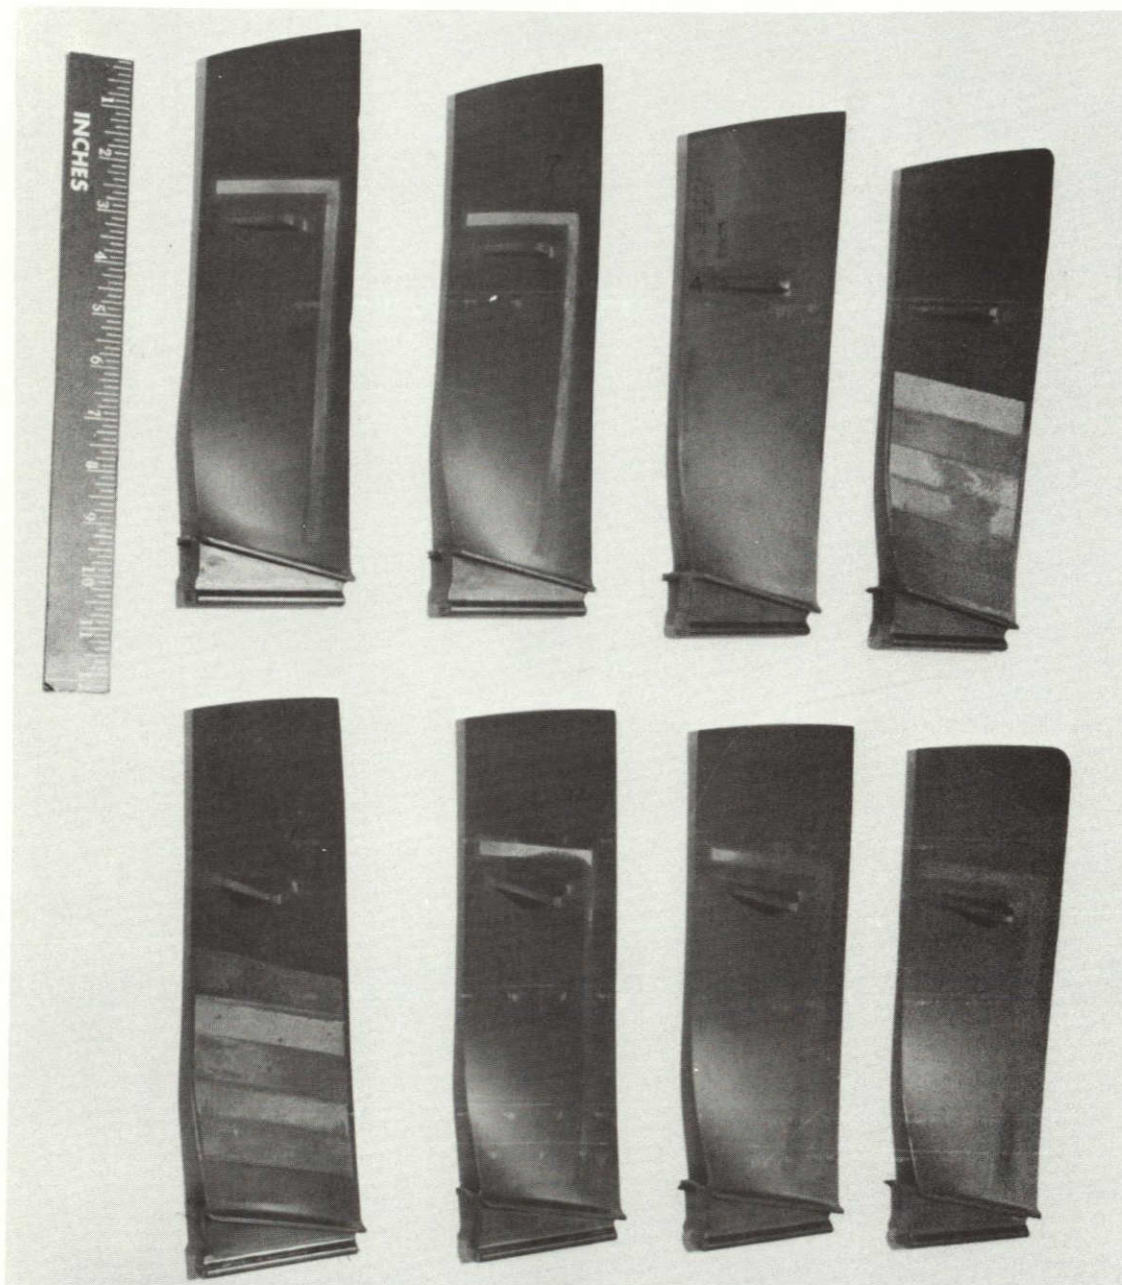
Figure A-17 Erosion Patch First Stage Blades S/N 2, 4, 7, 8, 10, 11, 12, 15 After Testing (78-444-0374-A)

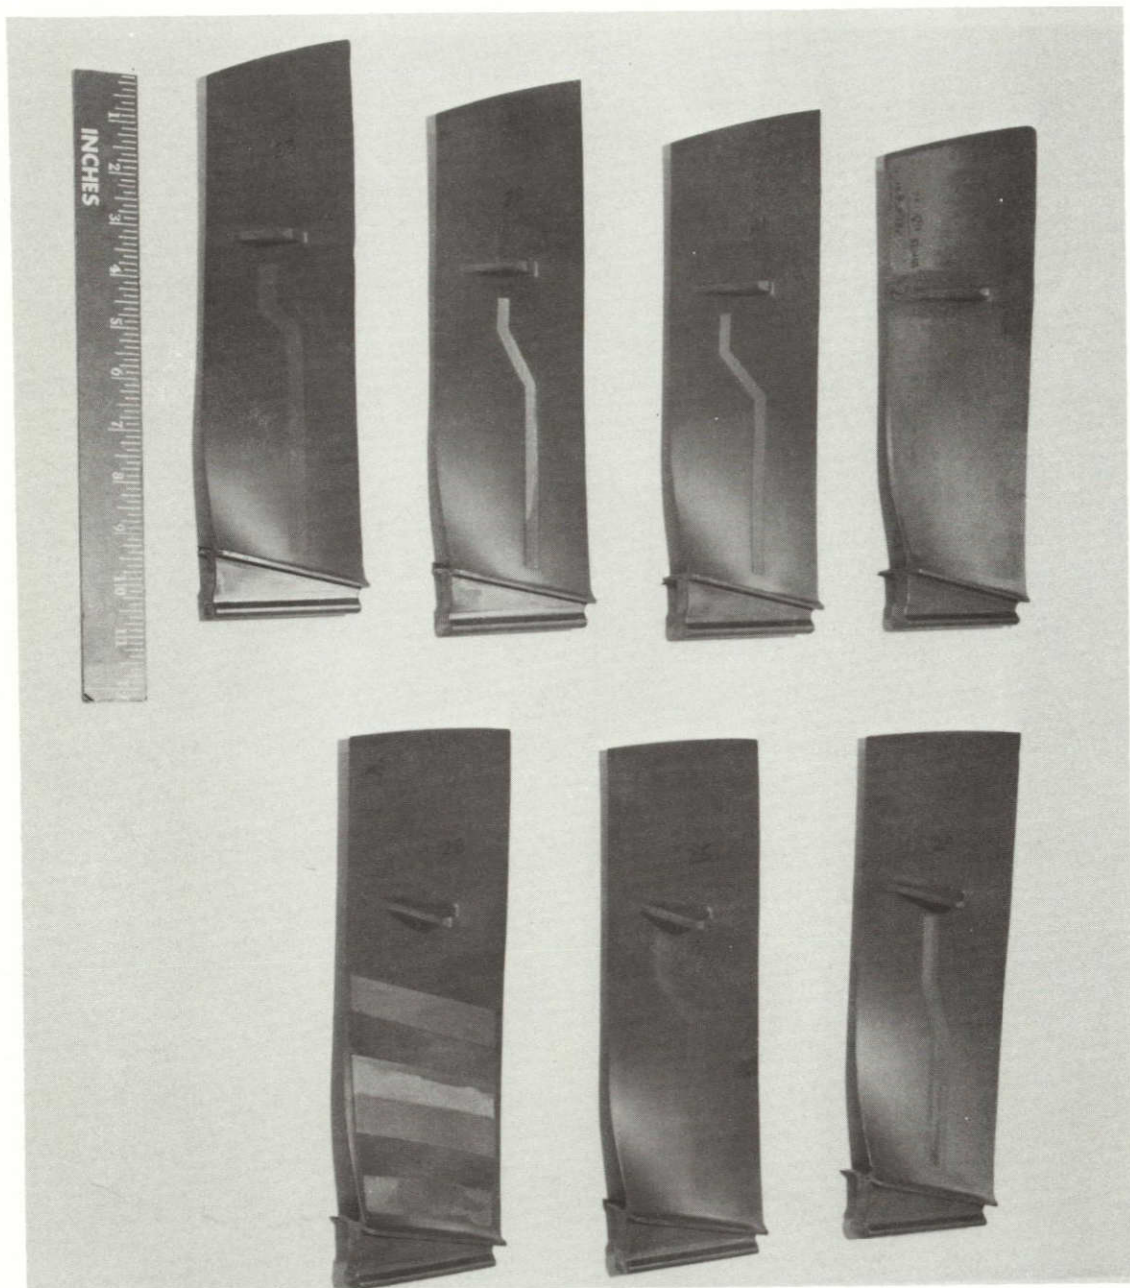
Figure A-19 Erosion Patch First Stage Blades S/N 17, 21, 22, 23, 24, 25, 28 After Testing (78-444-0374-B)

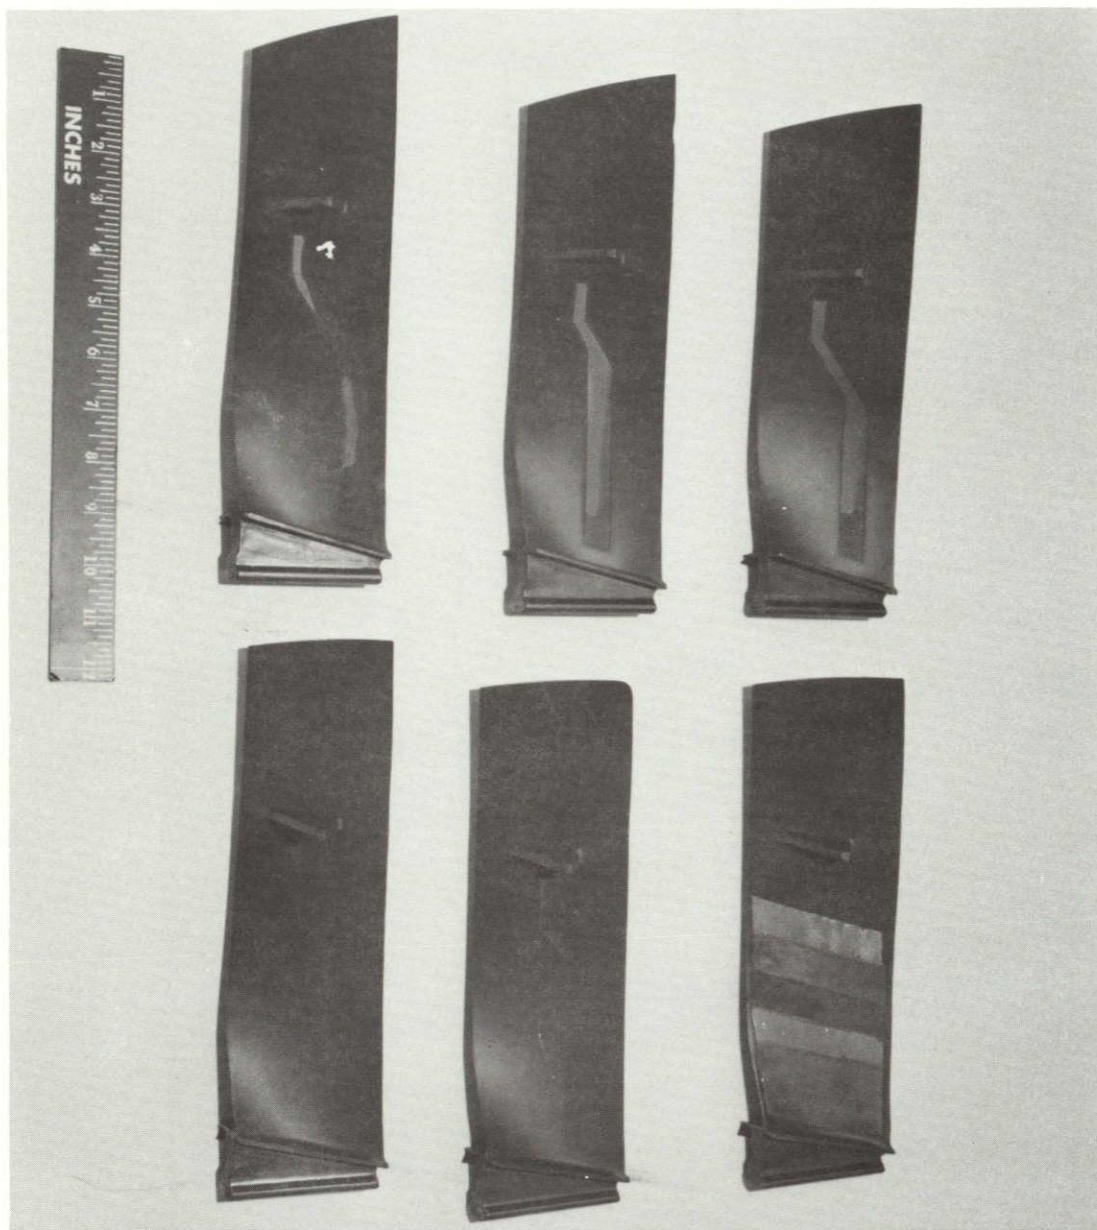
Figure A-21 Erosion Patch First Stage Blades S/N 30, 33, 34, 36, 37, 38 After Testing (78-444-0374-C)

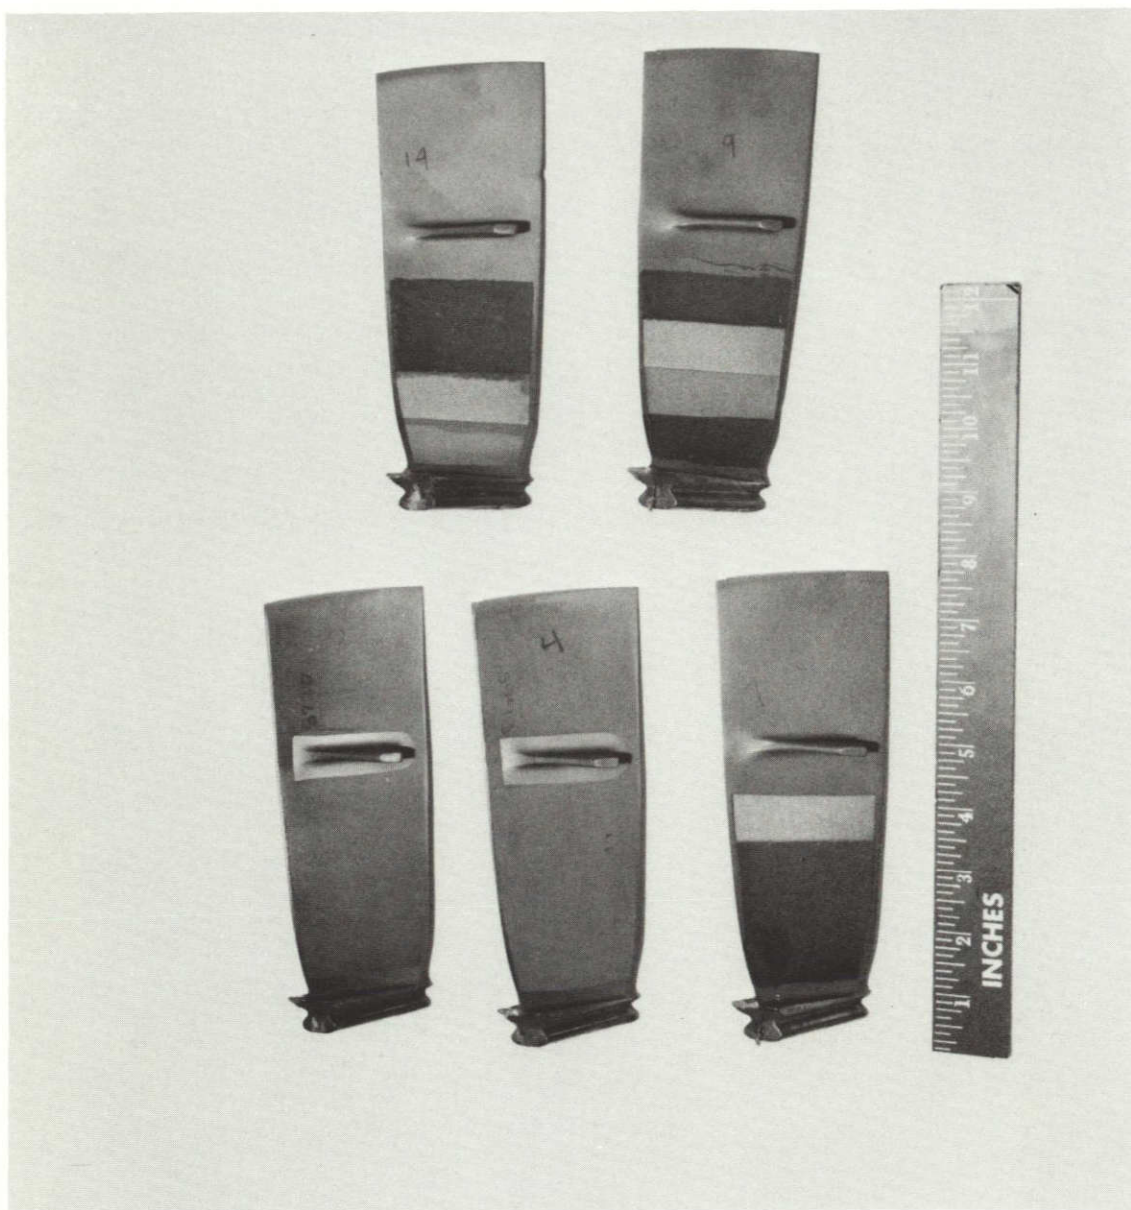
Figure A-33 Erosion Patch Third Stage Blades S/N 2, 4, 7, 9, 14
After Testing (78-444-0374-E)

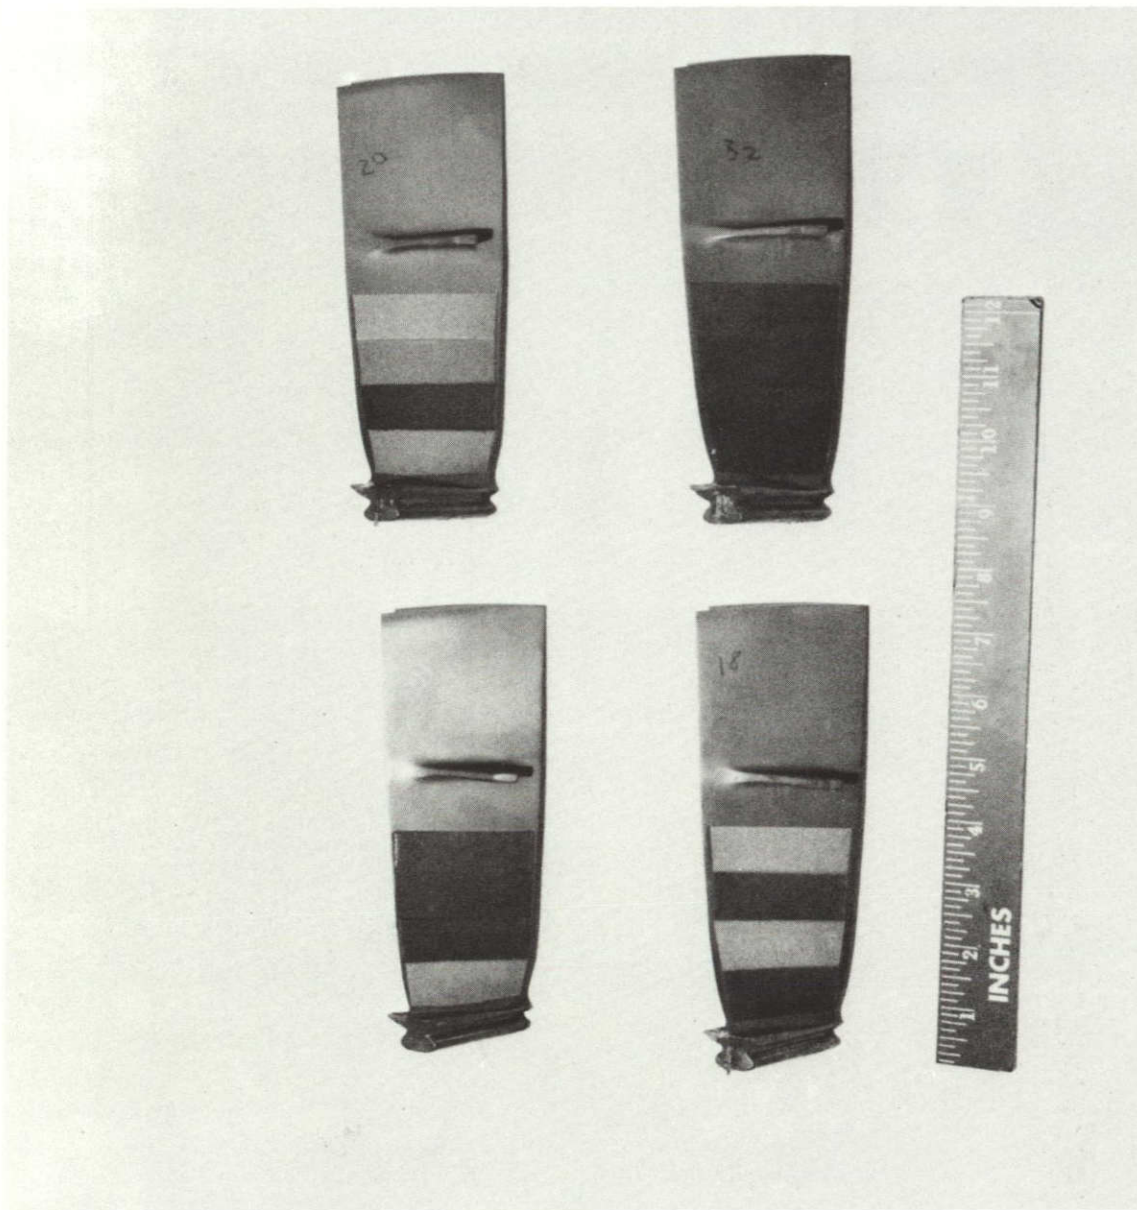
Figure A-35 Erosion Patch Third Stage Blades S/N 16, 18, 20, 32
After Testing (78-444-0374-D)

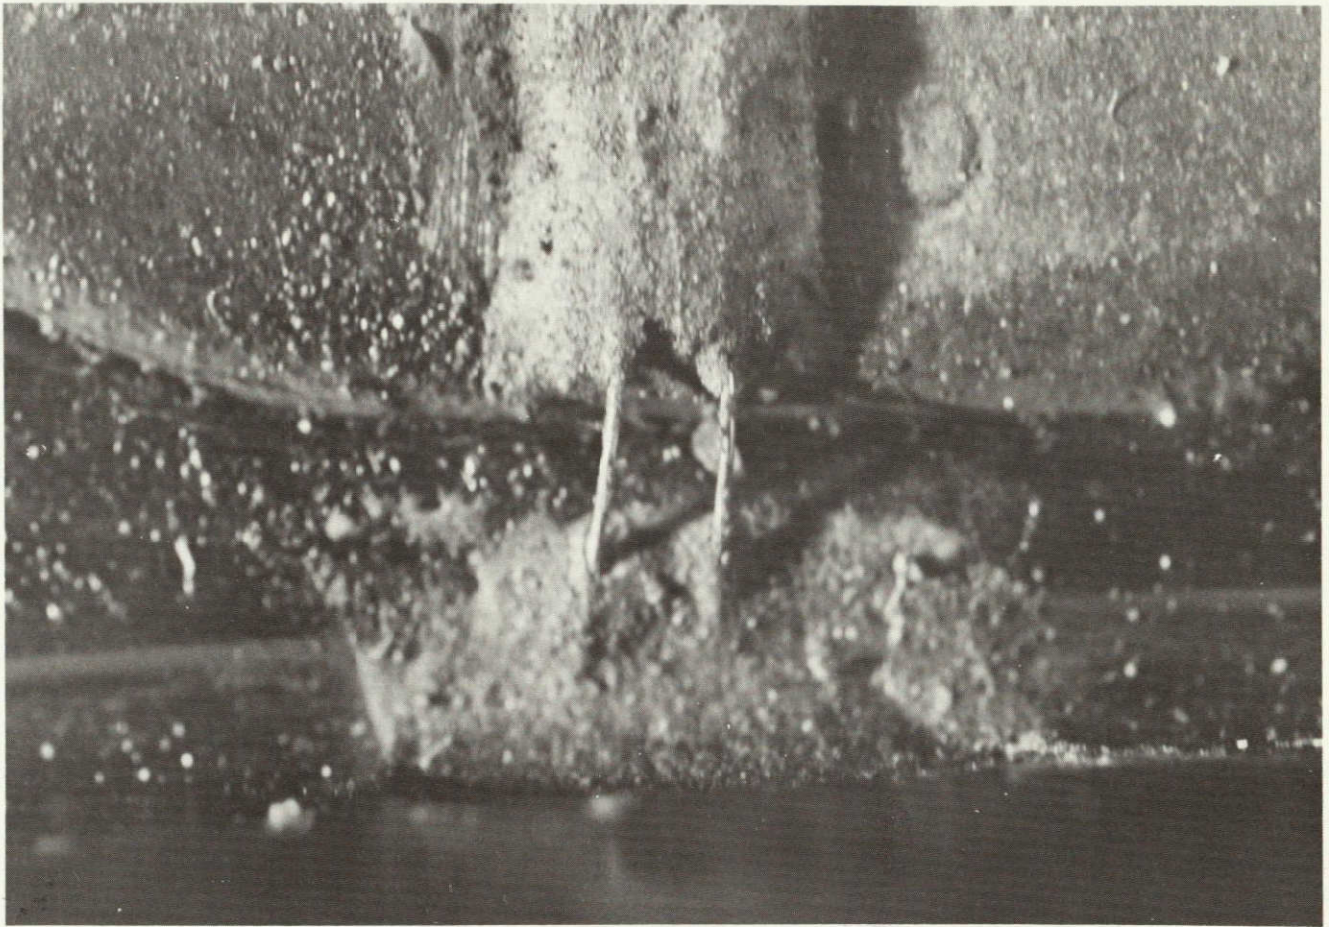
Figure A-36 Third Stage Blade to Disk Jump With Good 36 Gage Chromel
P Wires (78-444-0340-D)
